Thermostat housing corrosion of a 2000.

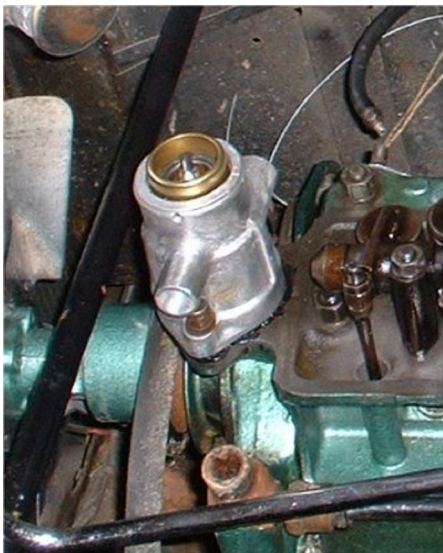
When new.....

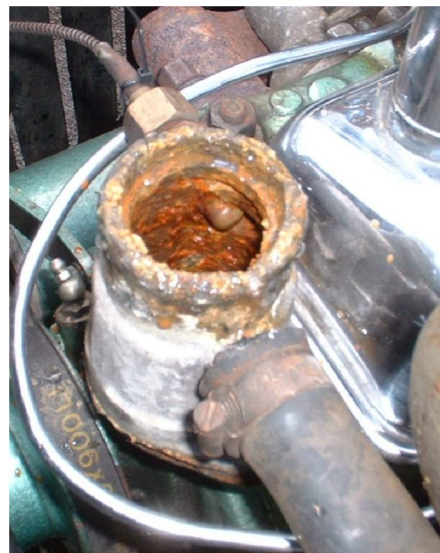
The whole of the top end of the housing had been eaten away to the top retaining "grub" screws. The left hand screw had the top 15% missing, the right less than a millimetre intact.

Right view.

The thermostat being copper re-acts with electrolysis against aluminium and needs a zinc anode to arrest this corrosion. Any ideas.

One idea I have had is that the housing should be machined within to allow a rubber grommet to be fitted between the aluminium housing and thermostat thereby removing direct contact of aluminium/copper/brass.

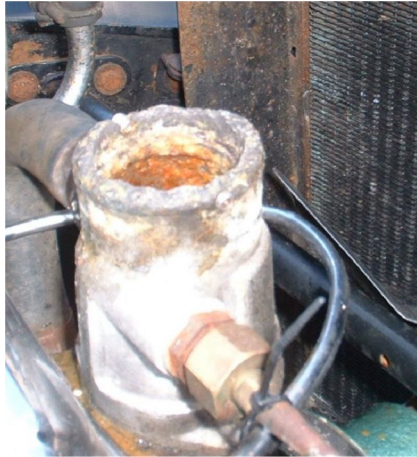
Left view.....

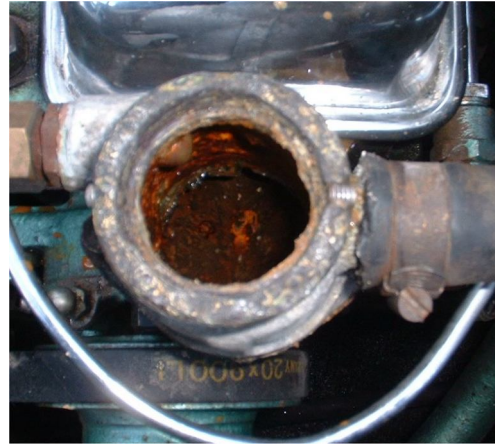
And overall view showing corrosion and old thermostat. (The pictures looked ok on camera but unfortunately the sun (!!!) has deleted the clarity of the excessive corrosion)

The old thermostat was heavily corroded into place and careful digging was needed to clear the area down to the thermostat lip. The grub screws were wound out very gingerly till the inner end was clear of the lip, and did not offer much resistance. The thermostat had to be “nudged” by a rubber hammer to loosen it before it came free. The top end of the housing was cleaned as far as possible without damage to the grub screws, before replacing the new thermostat, and the grub screws gently eased to trap the lip, with no pressure against the thermostat.

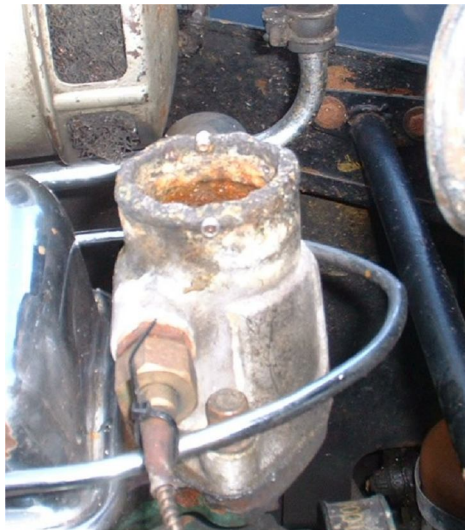
On returning to Mallorca I drained and flushed the system, refilled with distilled water, and cleaned the thermostat housing which as you will see was 3 months growth or corrosion on the housing, and decided to use remedy #2, this I will leave for a month. Remedy #3 is not an option as the engine will not reach normal operating temperature.

September 2009 clean.

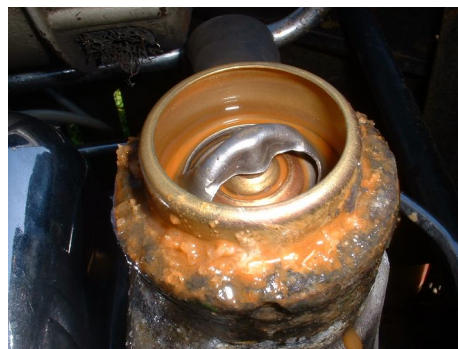
January 2010 removal.

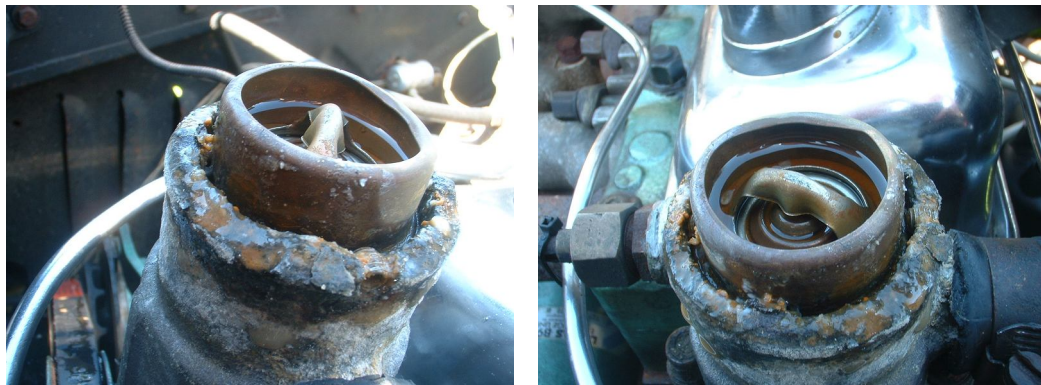
From January 2010 through to March I used no anti-freeze, and on every outing prior to starting opened and cleared the blocked drain plug of rust debris with a 12" electrical tie inserting "every way which way" clearing the block cooling channels. Every top up was with at least a litre of distilled water (I use a dehumidifier which produces water at the rate of 2 litres per day, yes, Mallorca is very damp in winter). On opening up the system after nearly 3 months the corrosion had continued as before, so it is not the anti-freeze.

So with the 2 options of 3 removed from the equation we are left with change anti-freeze. This has been done from yellow to green ethylene glycol, which according to the March Review is OK. However, up till now with or without anti-freeze has caused corrosion of the top of the thermostat housing and the only solution after trying many experiments with rubber grommets and plastic insertions, (no comments please), is an epoxy coating as used on ships and yachts to protect their hulls against electrolysis.

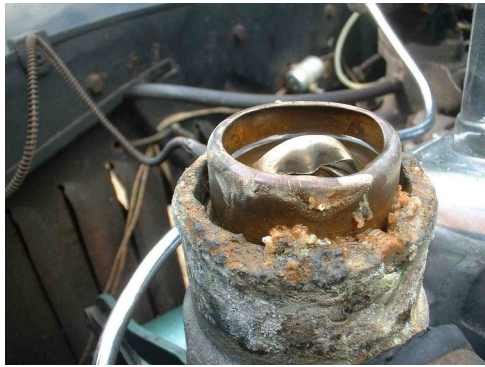
As you see below the corrosion had continued and as one of the grub screws was now about to become free I decided it was time to replace with my new epoxy resin coated housing.

In situ before removal.

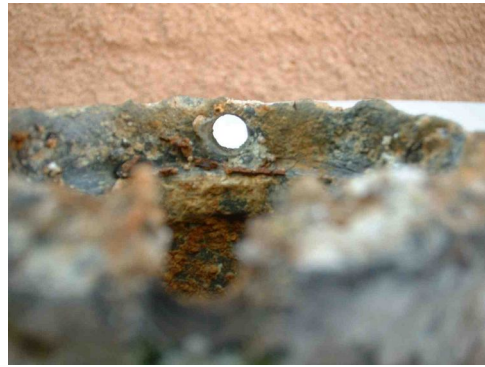
After removal.

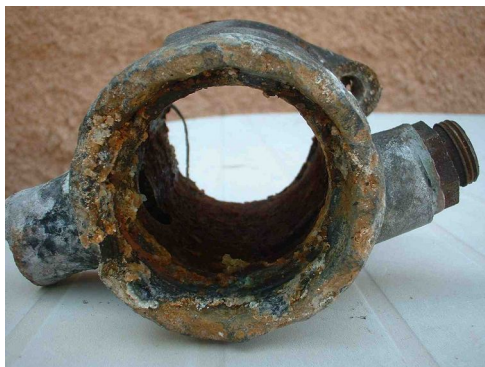
After removal.

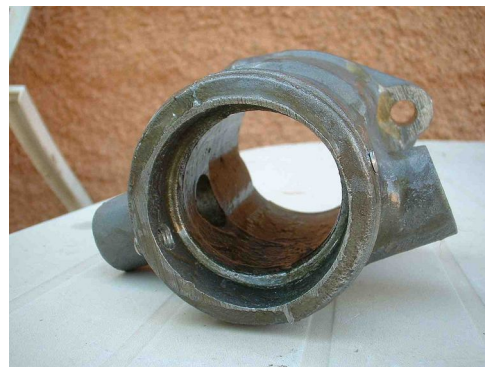
New epoxy resin housing.

Time will tell on how effective the coating turns out to be. The following pictures were taken at the time of replacement.

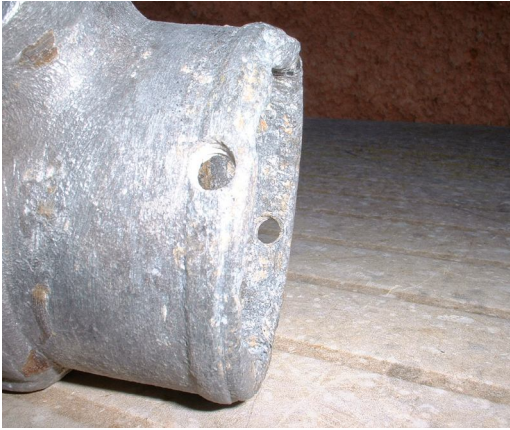
In January 2014 the bronze thermostat housing became available, however, the Epoxy Resin coated thermostat had begun corroding, having done 19,601 miles.

Old epoxy resin cleaned up showing pitting and corrosion. Note resin failed to remain attached.

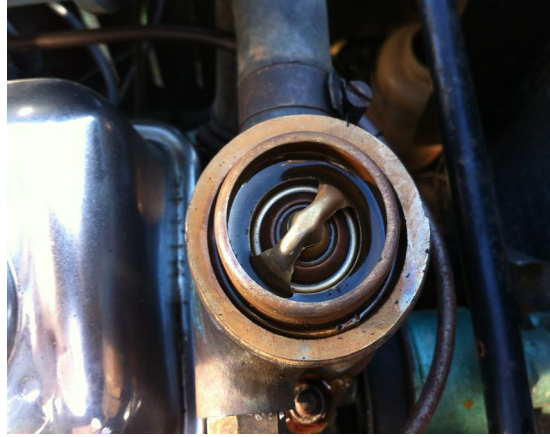
In February 2015, I checked the bronze housing, it was as clean as when it was fitted, after 6,620 miles.

Bronze housing after 13 months

So I think we can safely say that if you fit the bronze housing corrosion is behind you.
