## Thermostat housing corrosion of a 2000.

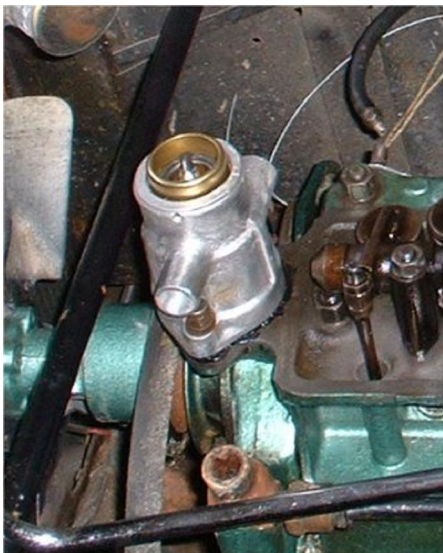
The whole of the top end of the housing had been eaten away to the top retaining "grub" screws. The left hand screw had the top 15% missing, the right less than a millimetre intact.

When new.....

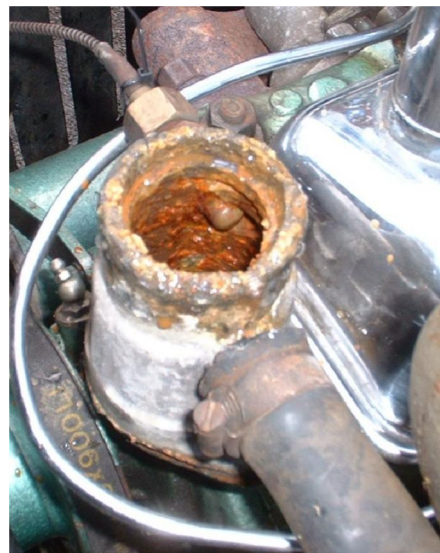
Right view.

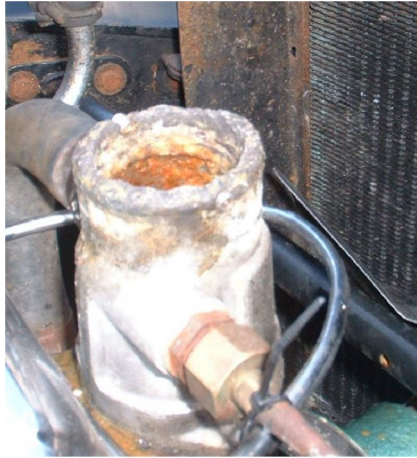
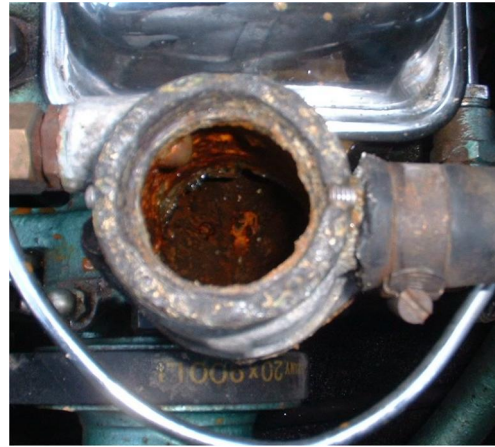
Left view.....

And overall view showing corrosion and old thermostat. (The pictures looked ok on camera but unfortunately the sun (!!!) has deleted the clarity of the excessive corrosion)

The old thermostat was heavily corroded into place and careful digging was needed to clear the area down to the thermostat lip. The grub screws were wound out very gingerly till the inner end was clear of the lip, and did not offer much resistance. The thermostat had to be “nudged” by a rubber hammer to loosen it before it came free. The top end of the housing was cleaned as far as possible without damage to the grub screws, before replacing the new thermostat, and the grub screws gently eased to trap the lip, with no pressure against the thermostat.

The thermostat being copper re-acts with electrolysis against aluminium and needs a zinc anode to arrest this corrosion. Any ideas.

One idea I have had is that the housing should be machined within to allow a rubber grommet to be fitted between the aluminium housing and thermostat thereby removing direct contact of aluminium/copper/brass.

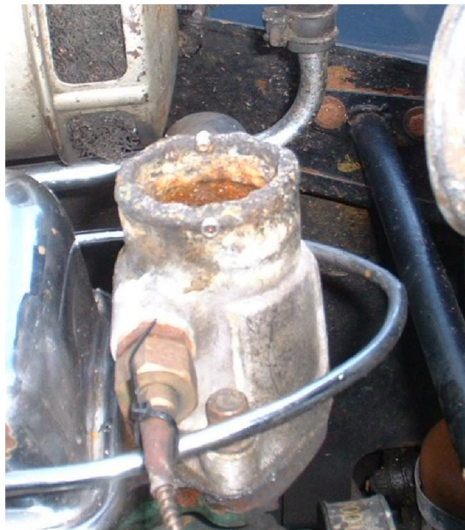
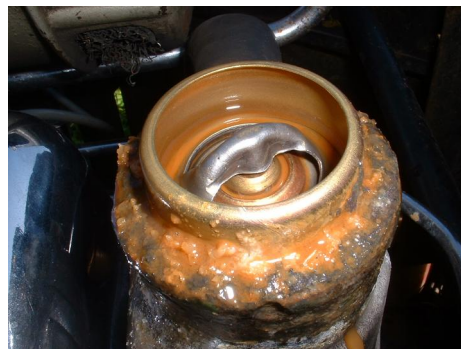
On returning to Mallorca I drained and flushed the system, refilled with distilled water, and cleaned the thermostat housing which as you will see was 3 months growth or corrosion on the housing, and decided to use remedy #2, this I will leave for a month. Remedy #3 is not an option as the engine will not reach normal operating temperature.

September 2009 clean.

January 2010 removal.

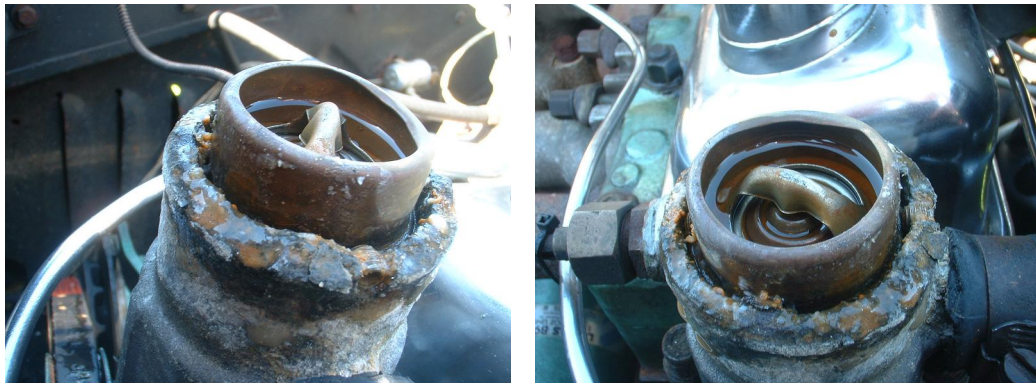
From January 2010 through to March I used no anti-freeze, and on every outing prior to starting opened and cleared the blocked drain plug of rust debris with a 12" electrical tie inserting "every way which way" clearing the block cooling channels. Every top up was with at least a litre of distilled water (I use a dehumidifier which produces water at the rate of 2 litres per day, yes, Mallorca is very damp in winter). On opening up the system after nearly 3 months the corrosion had continued as before, so it is not the anti-freeze.

So with the 2 options of 3 removed from the equation we are left with change anti-freeze. This has been done from yellow to green ethylene glycol, which according to the March Review is OK. However, up till now with or without anti-freeze has caused corrosion of the top of the thermostat housing and the only solution after trying many experiments with rubber grommets and plastic insertions, (no comments please), is an epoxy coating as used on ships and yachts to protect their hulls against electrolysis.
